**PEMBROKE TOWN WALLS PROJECT**  
**ARCHAEOLOGICAL INTERPRETATION**  
**AND**  
**CONDITION SURVEY**

**Pembroke Design Limited  
Architects and Surveyors**

**Cambria Archaeology**

**AN ARCHAEOLOGICAL ASSESSMENT,  
MARCH-APRIL 2001  
(Project Record No. 42678)**

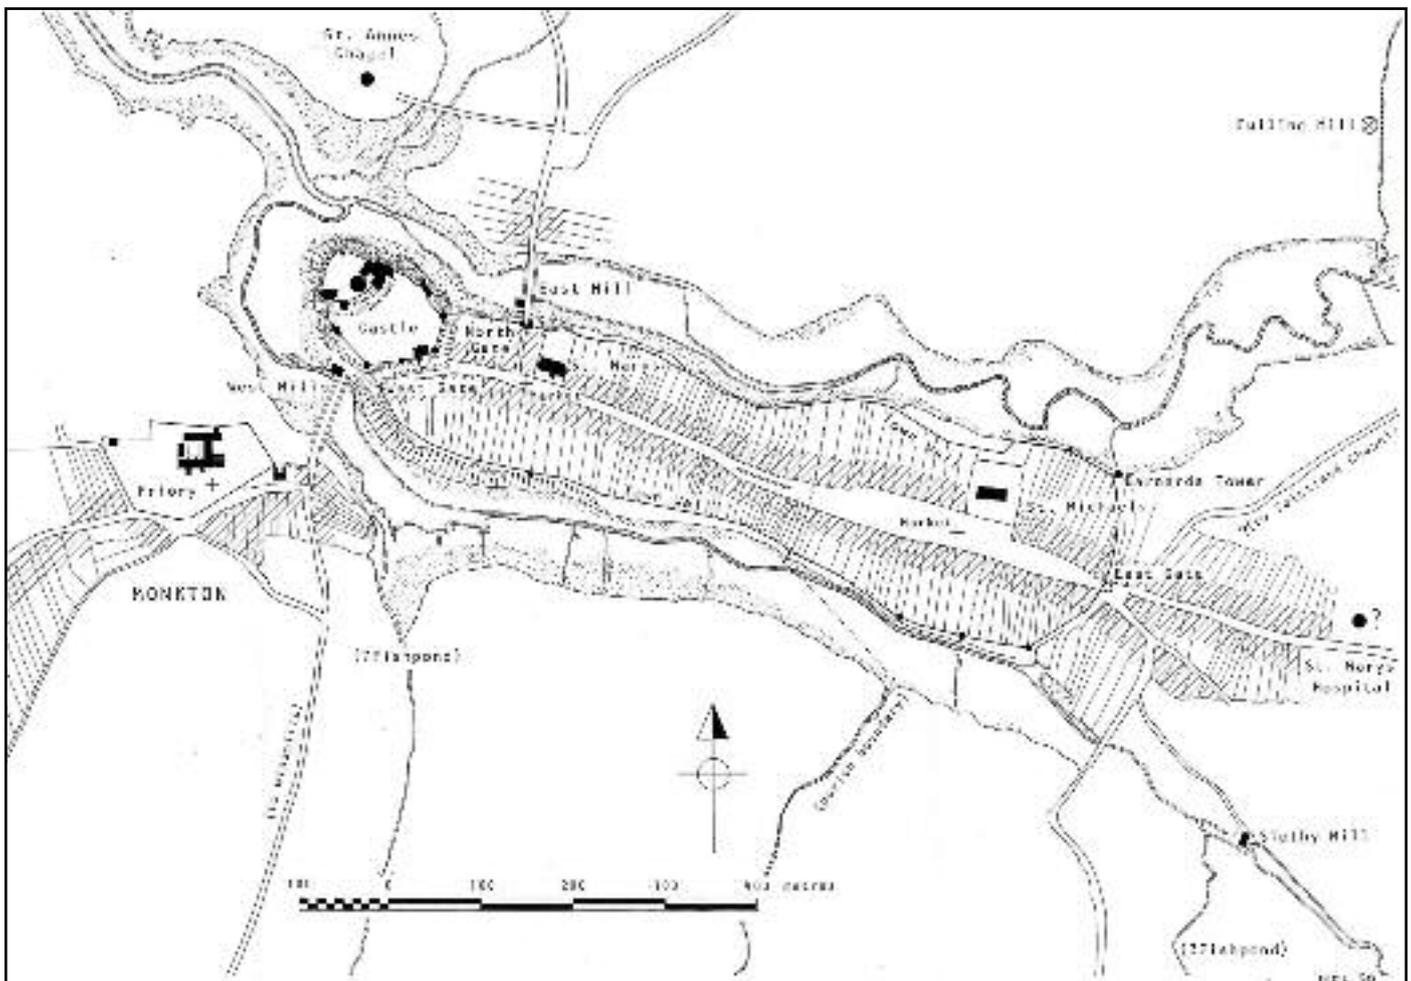
**Fig. 4 - Suggested Layout of Pembroke in c.1320.**

Pembroke's town wall encloses both St Mary's and the suburb of St Michael's (Fig. 4). It is suggested here that the present masonry defences are all of one phase, on the basis that the section nearest the castle - which, if more than one phase was represented, would necessarily be earliest - cannot plausibly have been commenced before the c.1280, when the castle outer ward was completed (see above). William de Valence, who held Pembroke at this time, was notable for his patronage of both Pembroke and Tenby - he made Pembroke his main seat of power, and residence, and founded hospitals at Tenby, and possibly Pembroke (King 1978, 9-10). Such interest in his local holdings may suggest

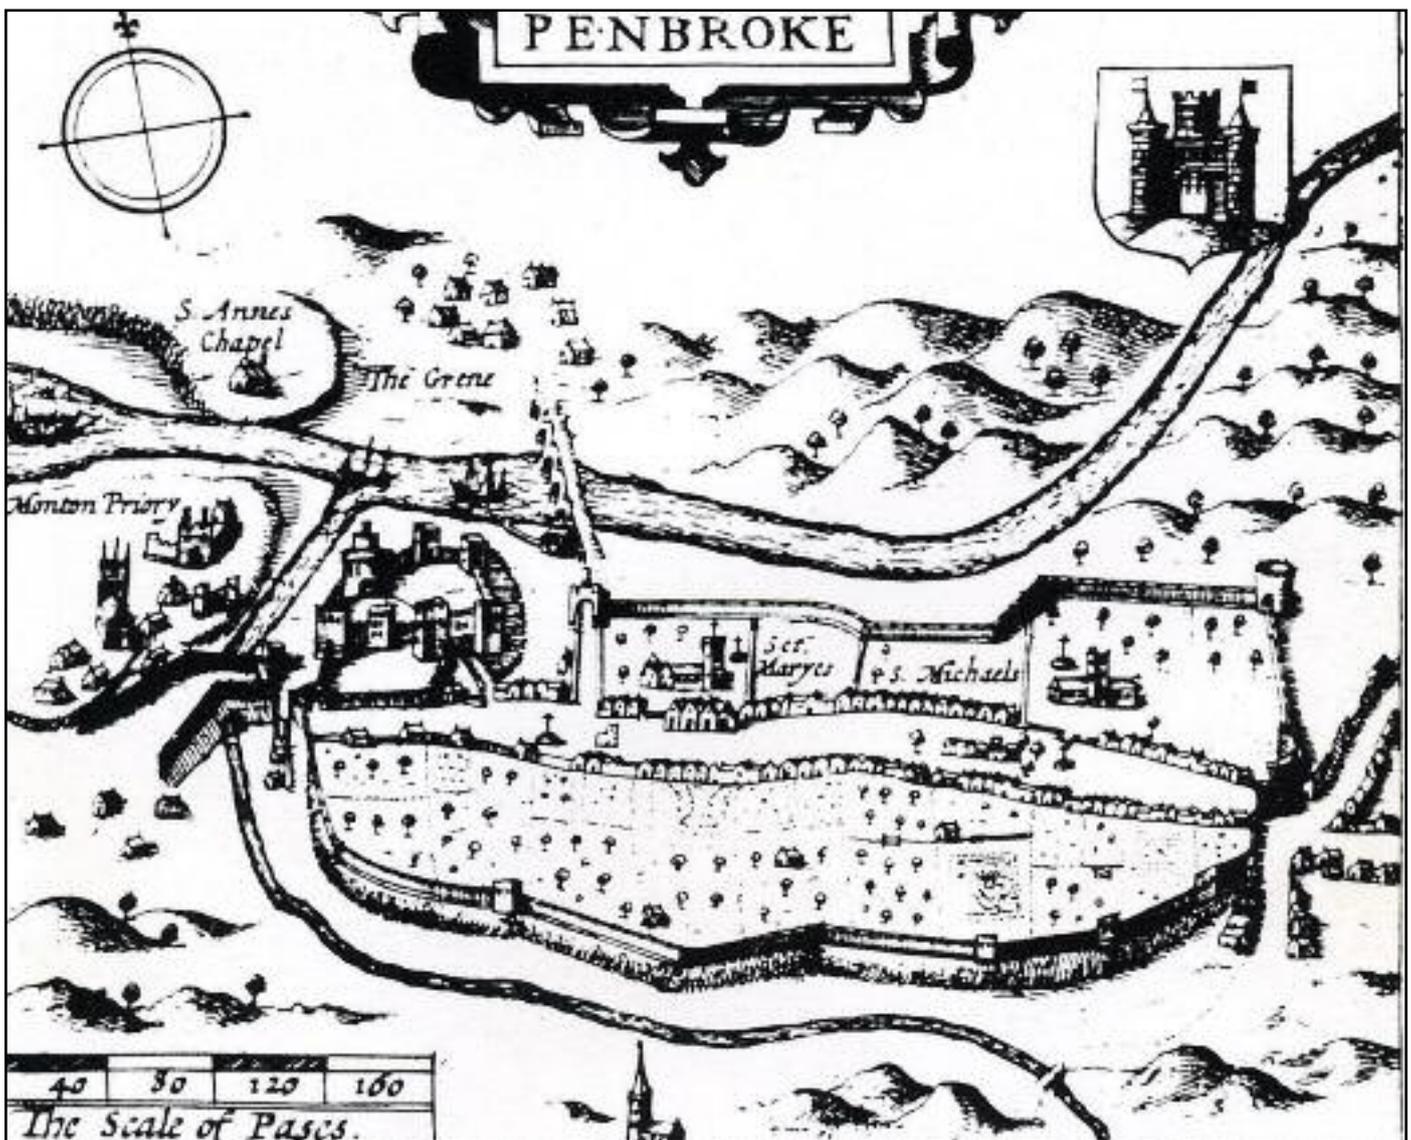
Fig. 5 - Speed's map of Pembroke in 1611

The East Gate, as described, appears to have possessed the barbican discussed above. Something similar appears to be shown on Speed's plan of 1611 which, although unclear, appears to be a semicircular structure with several arches (Fig. 5). The Speed plan is an invaluable source and shows the entire circuit as it stood in the early 17th century. The constriction at the 'waist' of the peninsula is emphasised, and indeed the way it is depicted is suggestive of the two-phase development of the defences outlined above. The northern line also runs inland towards the northwest corner of St Michael's churchyard, before heading north to the shoreline, along what is now a very pronounced scarp. Five flanking towers are shown, including the surviving Barnard's Tower, the two surviving towers on the southern line, and the tower which remains, in a fragmentary condition, at the southeast corner.

The surviving Semicircular Tower west of Barnard's Tower is not shown, the fifth tower being represented by a structure on the southern line just east of St Mary's Church, for which there is no physical evidence but which lies in an area that has been much altered by more recent development; the numerical discrepancy is accounted for in Owen's description of c.1600, reproduced below, which mentions six towers. Local tradition has it that the missing tower was associated with a postern at the foot of an alley now represented by Long Entry car park, but neither map nor documentary evidence can confirm this. As well as the East Gate, the North Gate is shown in a simplified form. The West Gate is also shown, but appears to be fronted by an additional gatehouse at the northern end of Monkton Bridge. This is not replicated in the French plan of c.1650 (Fig. 6) suggesting that it may have been removed during the 17th century, or was never present - there is no further evidence for this kind of structure, but a 'certain house... on the west bridge of the town of Pembroke' is mentioned in an account of 1480-81 (PRO Ministers' Account 1208/11, reproduced in Owen 1918, 146).

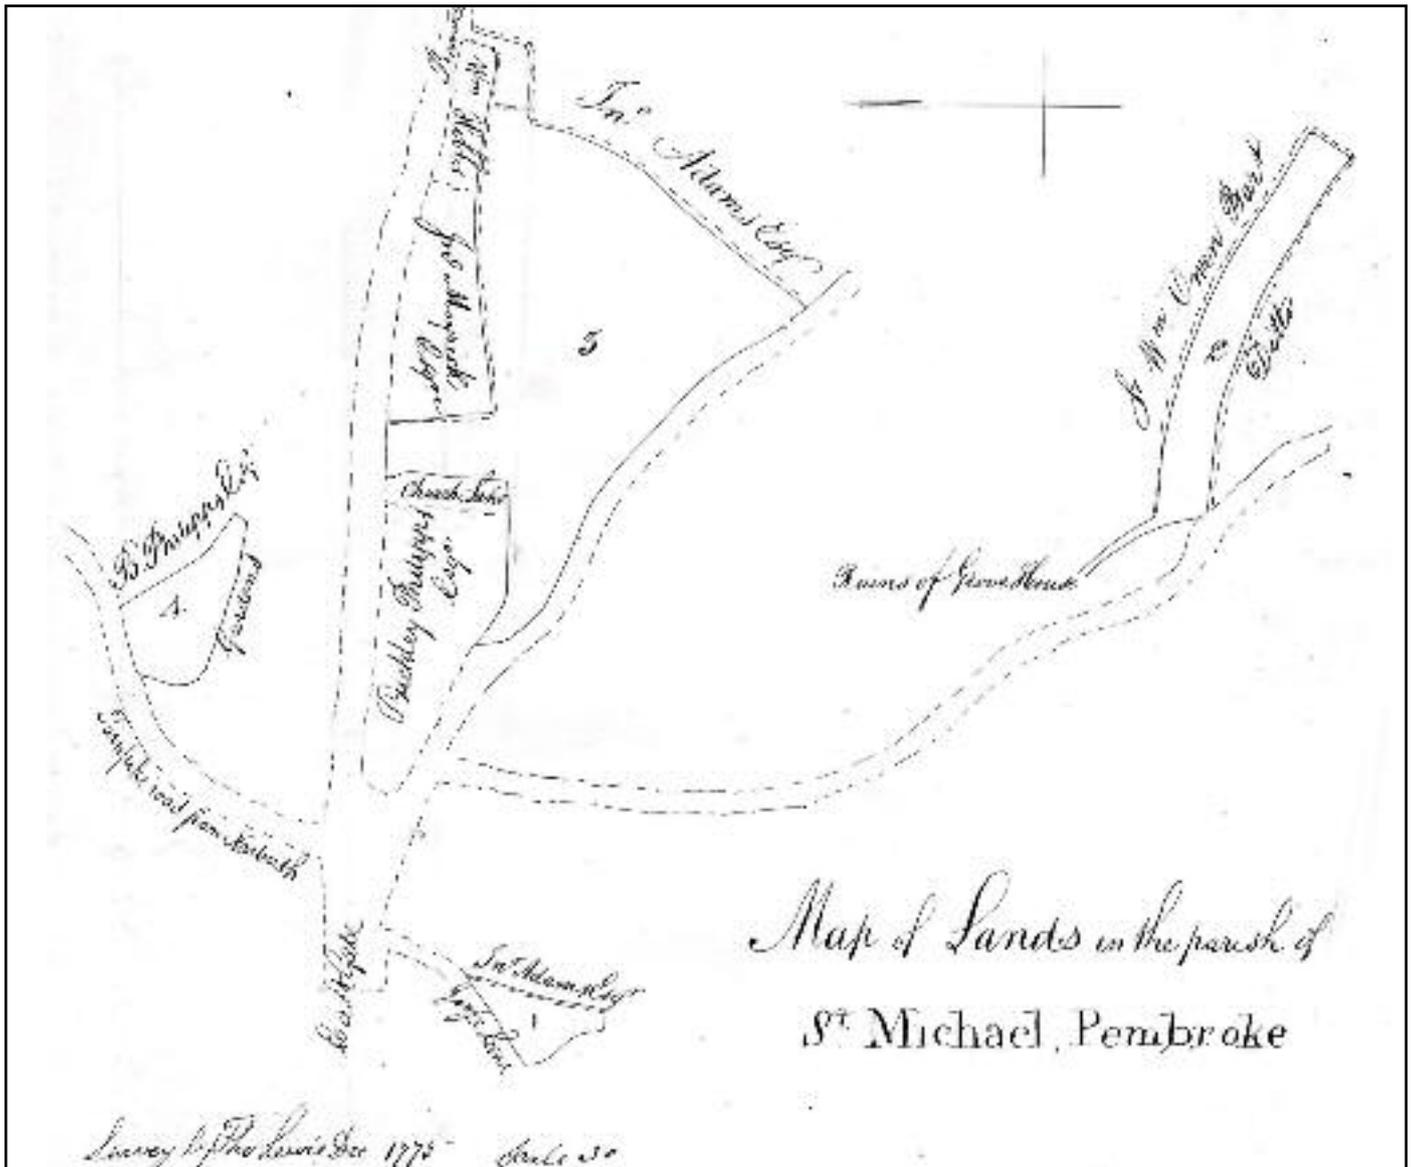
**Fig. 8 - Plan of East Gate area in 1775**  
(National Library of Wales, Map Book Vol. 88 'The Estates of  
Sir Rd. Phillips, Bart., 1774-5', 91 'Map of lands in the parish  
of St Michael, Pembroke, 1775')

The settled conditions that prevailed in Wales after the Civil War rendered town defences obsolete. The landward ditch fronting the east line of the walls must have been either infilled, or had silted, before 1775 when it already lay partly beneath Goose's Lane (NLW, Map Book Vol. 88). A new breach was constructed in the southern line of the wall, for a new lane, New Way, which was cut through a burgage plot in 1724 (Hindle 1979, 79) and was - and still is - the only cross street proper to be cut through the circuit since the medieval period.

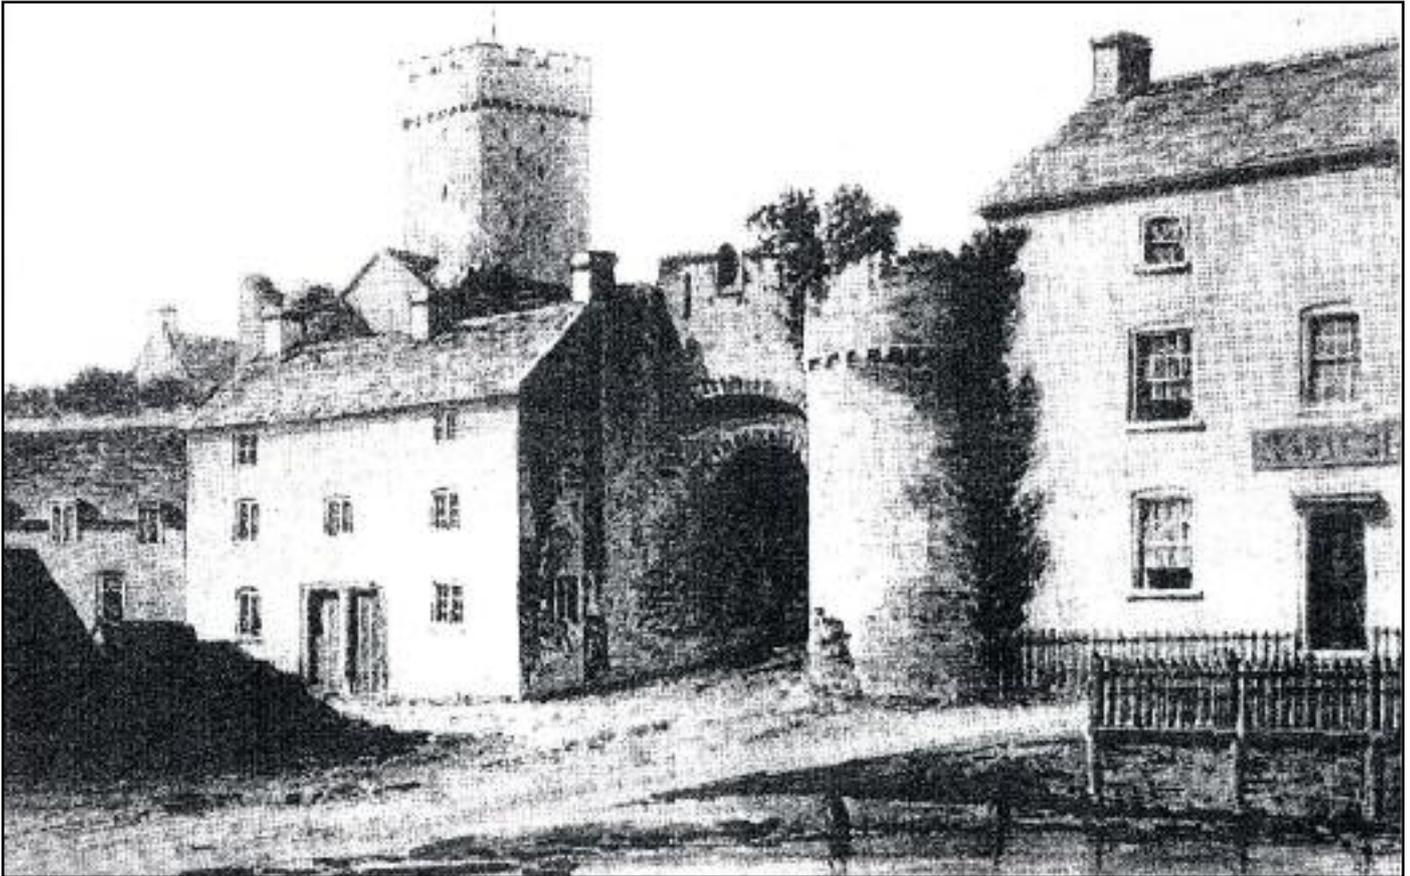
**Fig. 12 - J. C. Buckler's view of the North Gate in 1815**

Richard Fenton, writing in 1811, adds that there was 'a postern on the south side' (Fenton 1811, 362), evidently the only survivor from the 2+ posterns mentioned in 1480-81, and - unless Fenton was erroneously describing one of the later openings - this has been lost today. The North Gate was still standing in 1815 when it was painted by Buckler, but was demolished in c.1820 (Parkinson, 1979-80).
